**TOTAL MAXIMUM DAILY LOAD (TMDL)**

**UPPER RIO GRANDE WATERSHED (PART 2)**

**COCHITI RESERVOIR TO PILAR, NM**

**June 2, 2005**

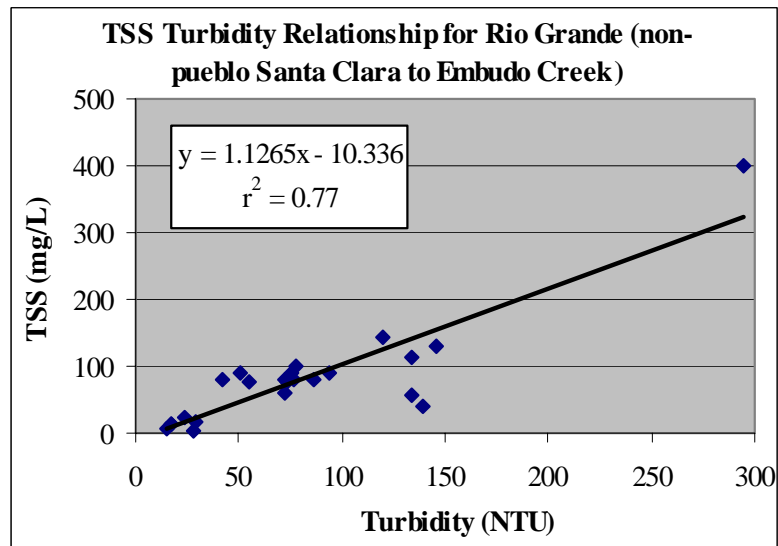
**Figure 6.2 Relationship between TSS and Turbidity for the Rio Grande (non-pueblo Santa Clara to Embudo Creek)**

TSS and turbidity were measured in Embudo Creek (Table 6.1), the Rio Grande (Table 6.2), and the Rio Santa Barbara (Table 6.3) during the 2001 survey. The TSS target was derived using a regression equation developed using measured turbidity as the independent variable and measured TSS dependent variable. The equation and regression statistics are displayed below in Figures 6.1, 6.2, and 6.3. Correlations of  $r^2=0.99$ , 0.77, and 0.98 were found between TSS and turbidity for Embudo Creek, Rio Grande, and Rio Santa Barbara, respectively.
